Powersave Test Cases

Goal: Test and verify powersave mode on a station using various methods.

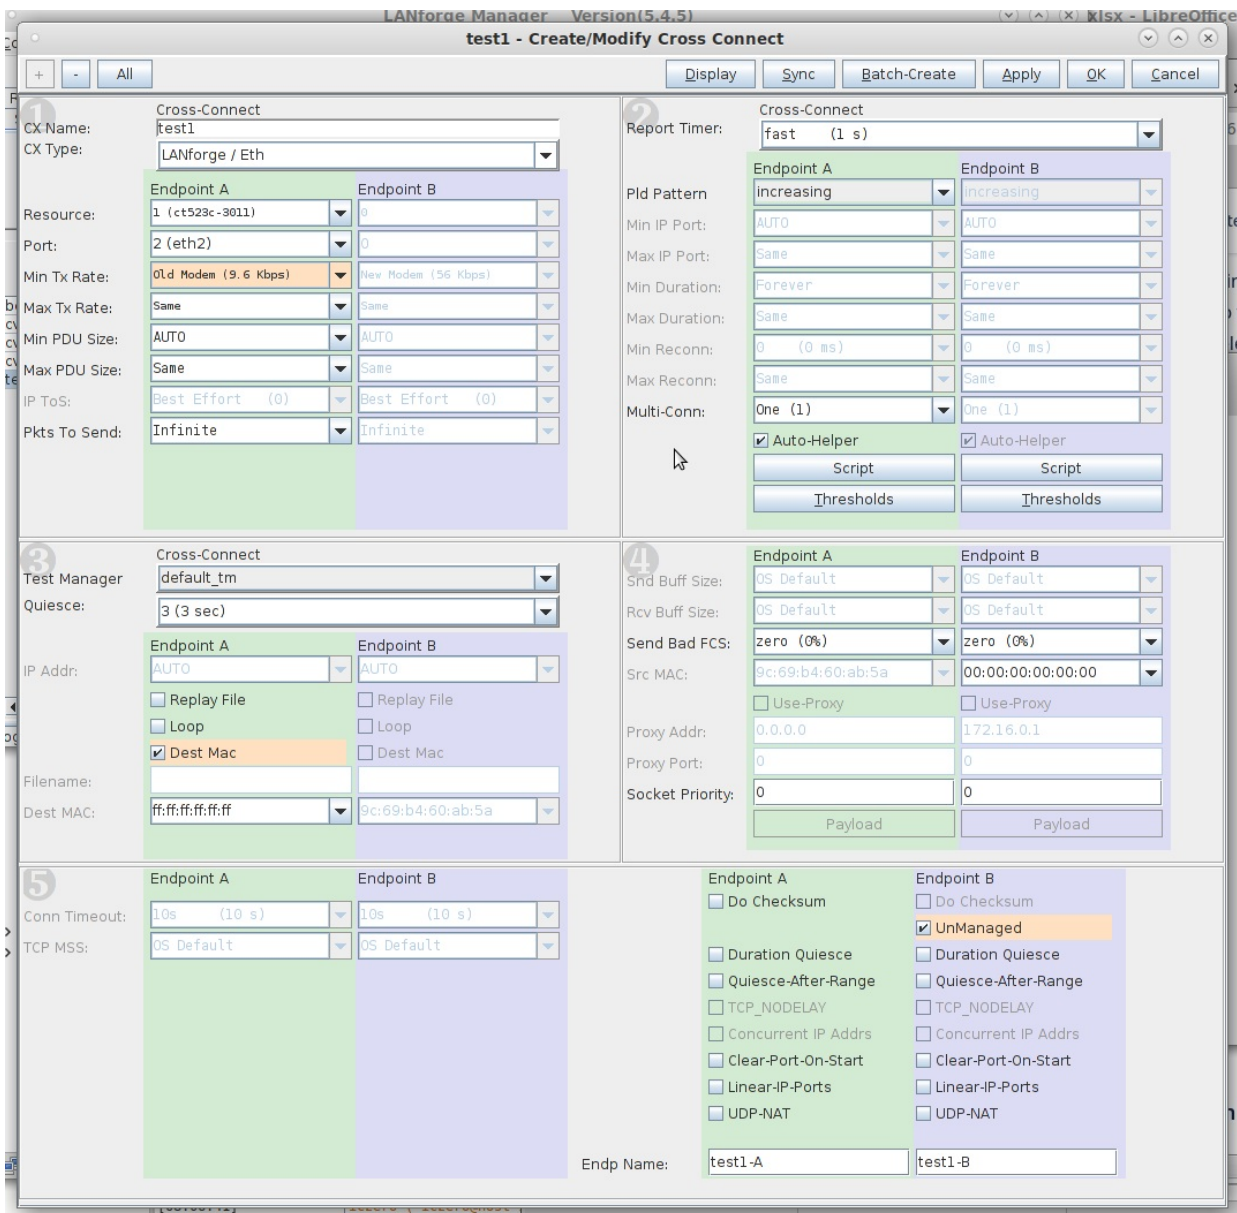
LANforge is configured to generate slow broadcast traffic in downstream direction using LANforge-Eth layer-3 connection type, with Dest Mac specified as all FFs, and 'b' side as un-managed. This causes A side to blindly send out these frames, the B side does not actually attempt to receive it.

This AP is not buffering broadcast packets and sending them after the beacon like it is supposed to. Frame 157 (beacon) does not have Multicast bit set in its TIM:

This pcap file shows bad broadcast Powersave behavior. Frame 157 TIM field should indicate Multicast and the broadcast frame 158 should be immediately after frame 157 instead of being 65ms later.
